TRAGEDY AT COOLANGATTA

Sixty years on, *Flight Safety* writer, Macarthur Job, looks at how a loading problem led to one of Australia's worst civil aviation accidents.

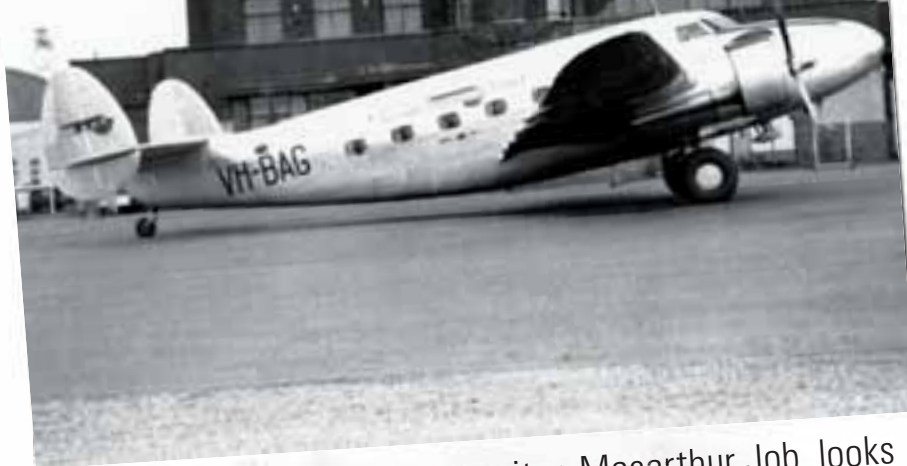
Queensland Airlines' Lockheed Lodestar VH-BAG, parked in front of Brisbane's Archerfield Airport terminal in the late 1940s.

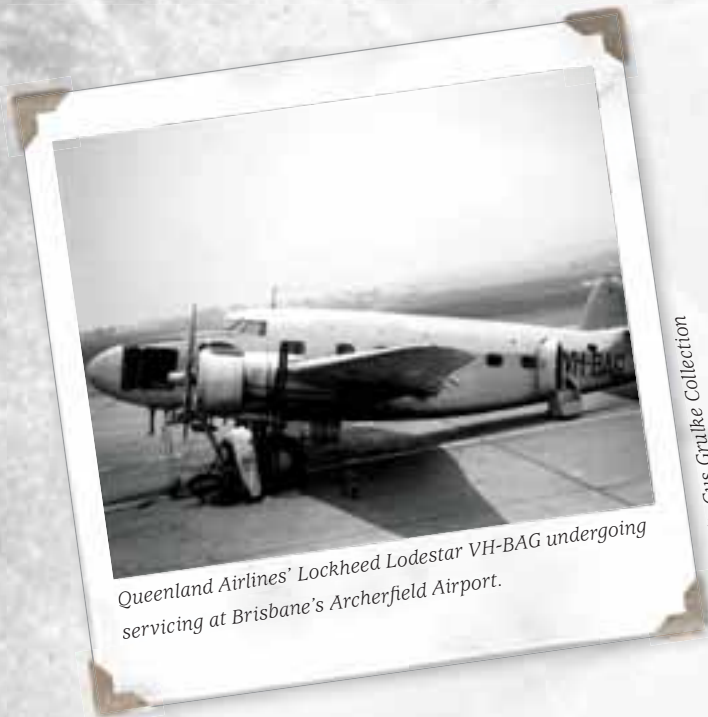
Queensland Airlines' Lockheed Lodestar VH-BAG undergoing servicing at Brisbane's Archerfield Airport.
